NEW MEXICO STEAM LOCOMOTIVE RAILROAD HISTORICAL SOCIETY

Vol. X, No. 4

A VERY GOOD YEAR

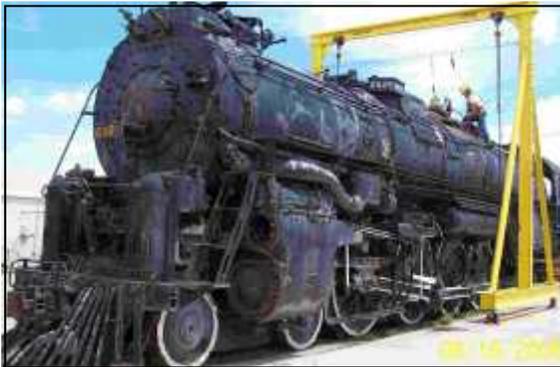
Before removal of outer skin, asbestos, appliances, piping etc., 2926 reveals rust and other results of years of abuse, exposure, and neglect.

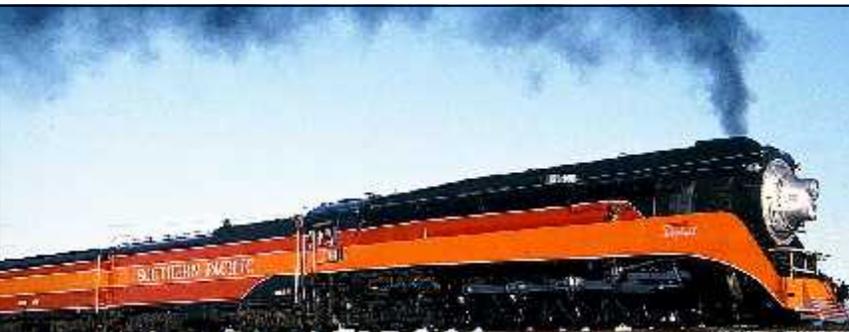
Southern Pacific #4449: When it operated as the Bicentennial American Freedom Train, it carried a red white and blue color scheme.

Southern Pacific #4449 was the first of the three to be restored. It was selected in 1974 for the starring role on the 1976 American Freedom Train, celebrating America's Bicentennial. After its American Freedom Train service it was restored to its original appearance and has operated in periodic excursion service ever since.

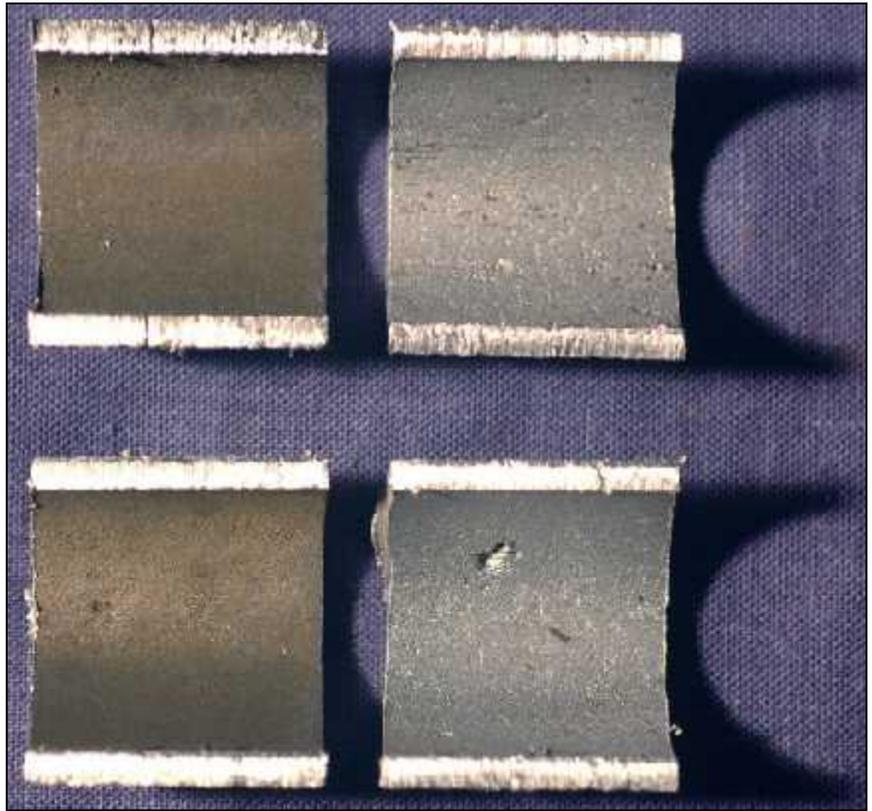
Sample sections from the superheater tubes that have been cut for analysis

Several tests were done, including x-ray diffraction (XRD), x-ray fluorescence (XRF), glass-bead blasting (GBB), and detailed microscopic analysis.

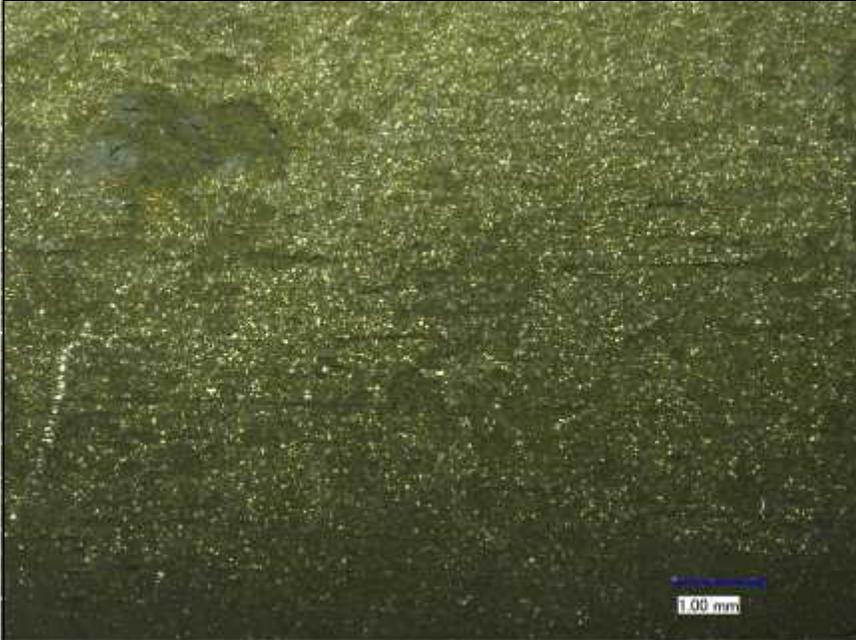
Figure 1: Microphotograph of acid-cleaned sample

Close microscopic observation revealed some shallow longitudinally grooves on the internal surface of the acid-cleaned sample, (See Figure 1). These features are typical of damage caused by acid cleaning. The attack on the acid-cleaned section looks minor, if not superficial. A few longitudinally oriented grooves were also present on the internal surface of the GBB sample (See Figure 2), but they were less numerous and not as deep.

The external surfaces look similar. Both sections had an irregular surface contour consisting of many depressions. The depressions on the acid-cleaned sample looked slightly deeper. Desch longitudinally split the portions to look at the internal surface, and noticed some moderately deep depressions in places on both sections. He thinks these depressions were caused by idle time oxygen corrosion over the years.

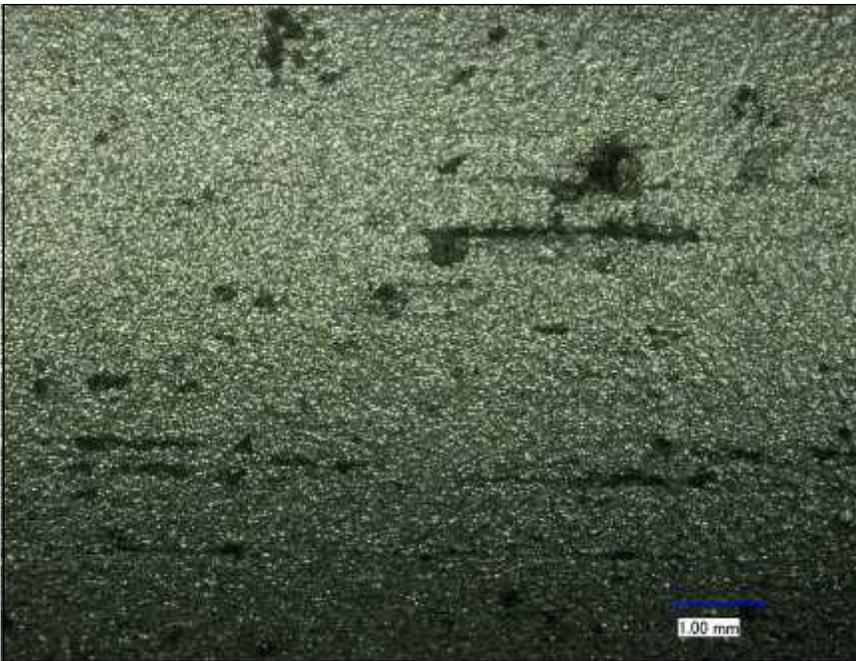
Figure 2: Microphotograph of GBB sample

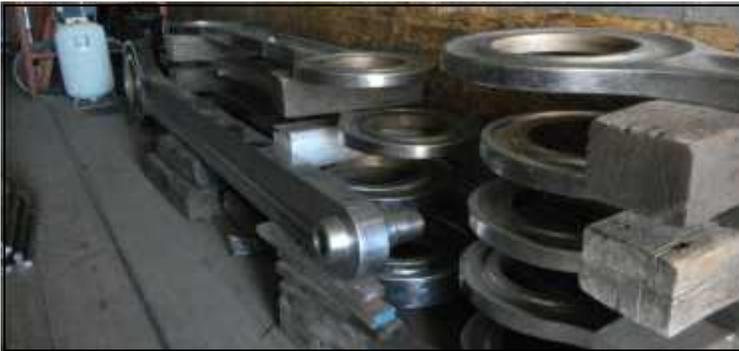
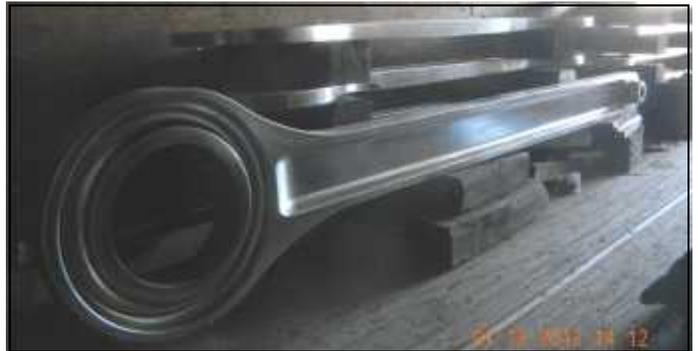
The highly polished side rods are stored inside one of our storage containers. Once their large roller bearings are returned for the Timken plant in South Carolina, they will be taken out of storage and reinstalled.

Many of our members were involved in this project for several months. Once removed, paint was removed from the rods, (they were not painted when the engine was in service). The alloy rods were buffed and shined to look like new and were then put into storage.

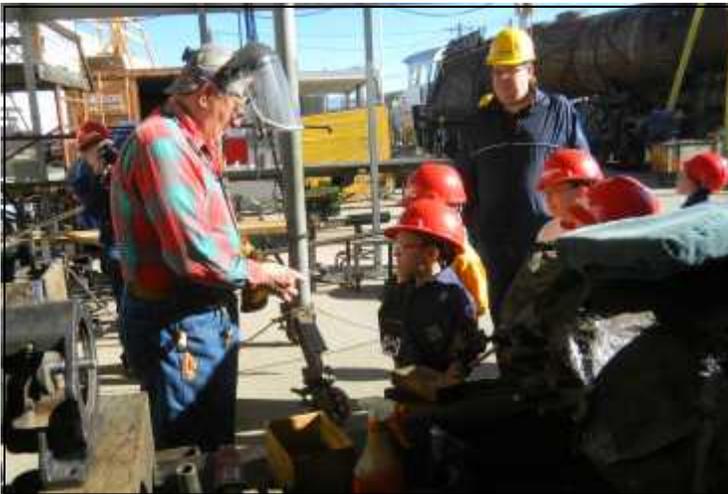
In the first picture, Bob DeGroft shows a group of Cub Scouts a rusted bolt, and explains that a new one will have to be made in the machine shop. In the second picture, Mike Hartshorne provides another group with a close-up description of 2926.
